Memorandum

Subject: Dose measurements around the NM3 target pile

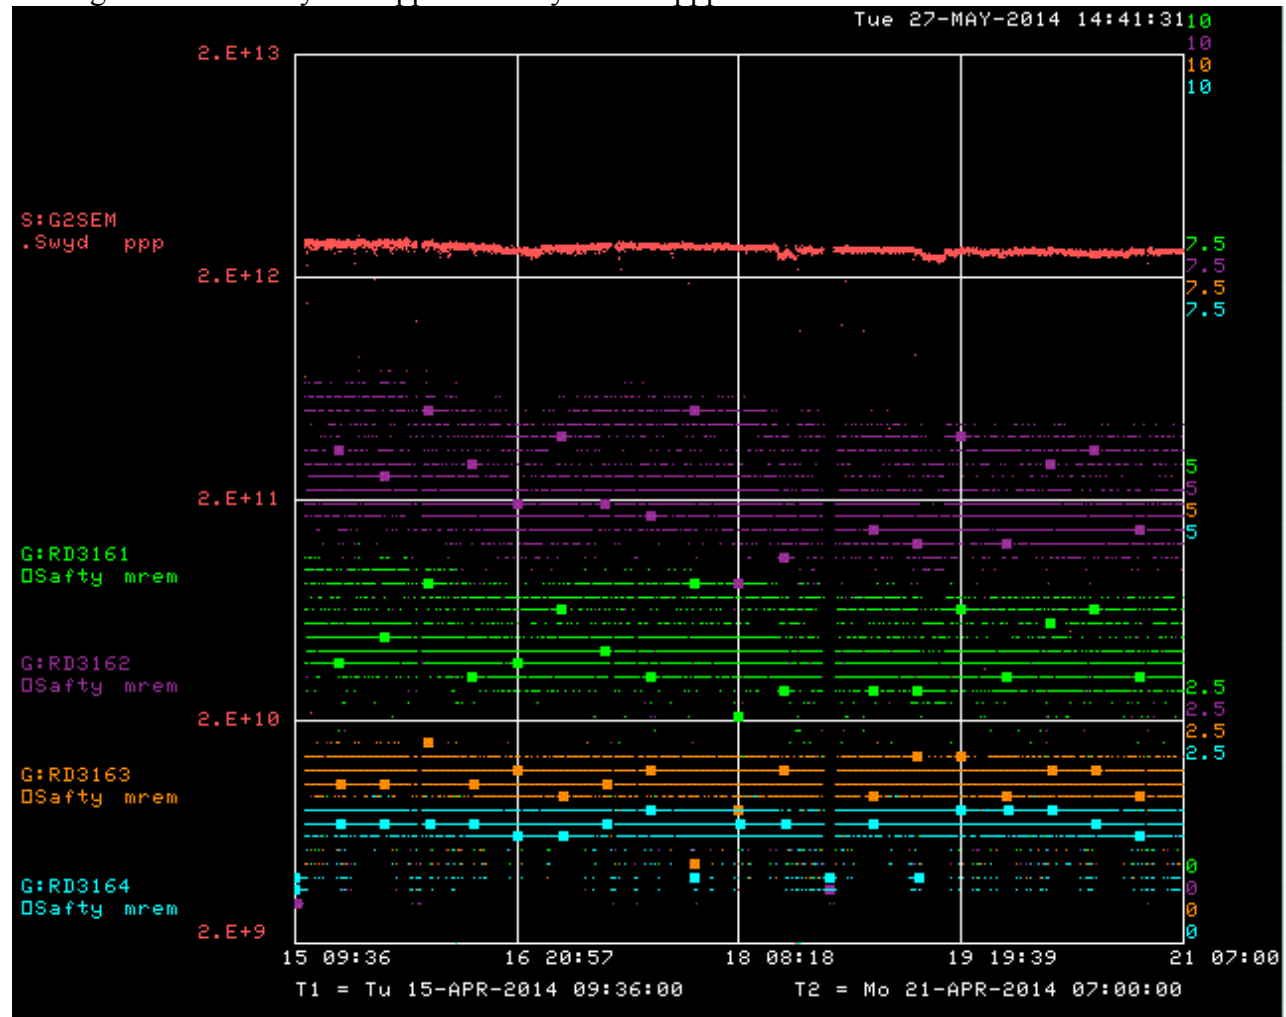
Normal beam operation continued from approximately 1100 on the 15th to 0715 on the 21st. Average beam intensity was approximately $2.3\text{E}12$ ppp.

Figure 2. The beam intensity on the G2SEM for the week and nearby chipmunk detectors.
